**BLUEWATER BEACH ENVIRONMENTAL RESTORATION  
PLAN**

**PHASE 2 REPORT**

**TC 61406  
March 2007**

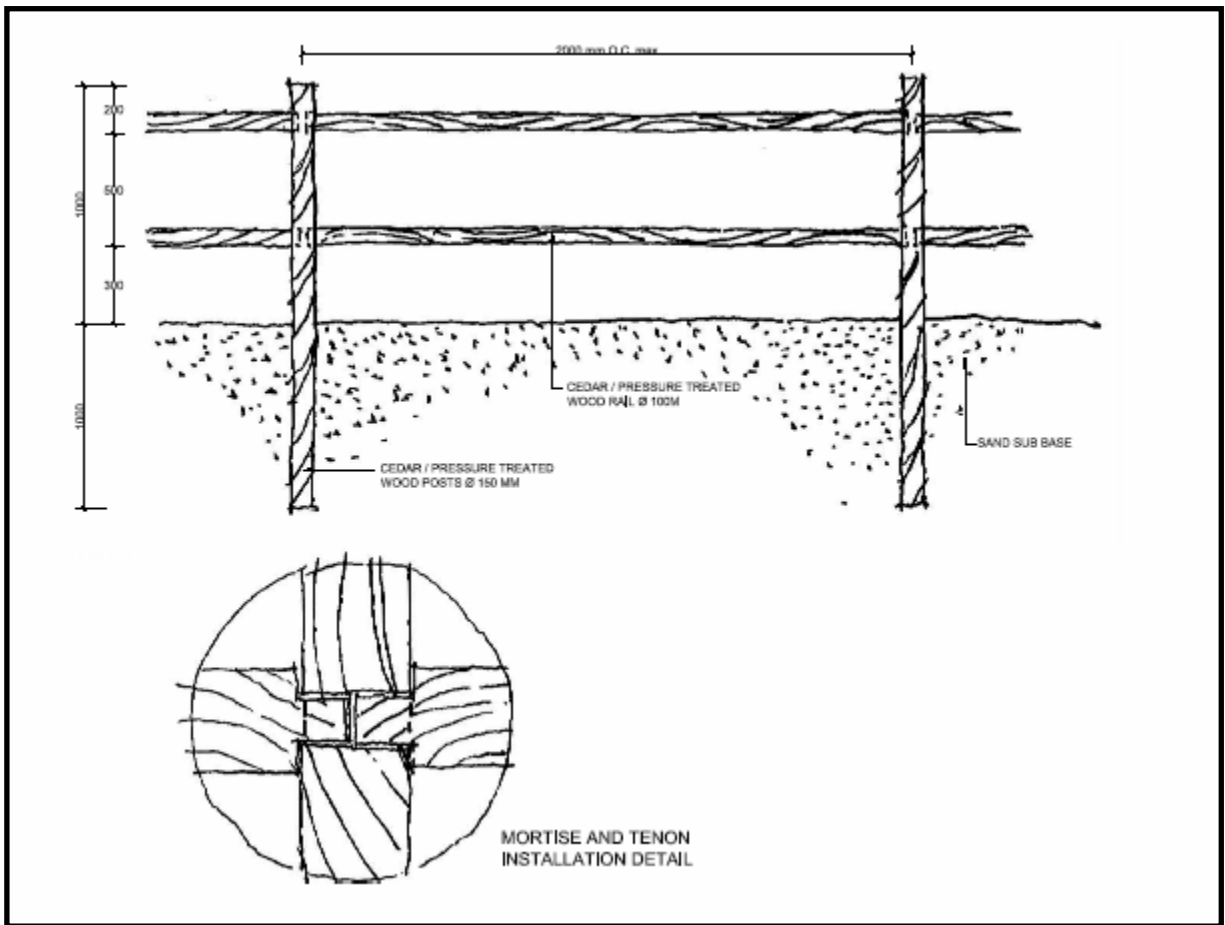
**Figure 6: Farm fencing detail between beach and dune system and for the end of Trew Avenue**

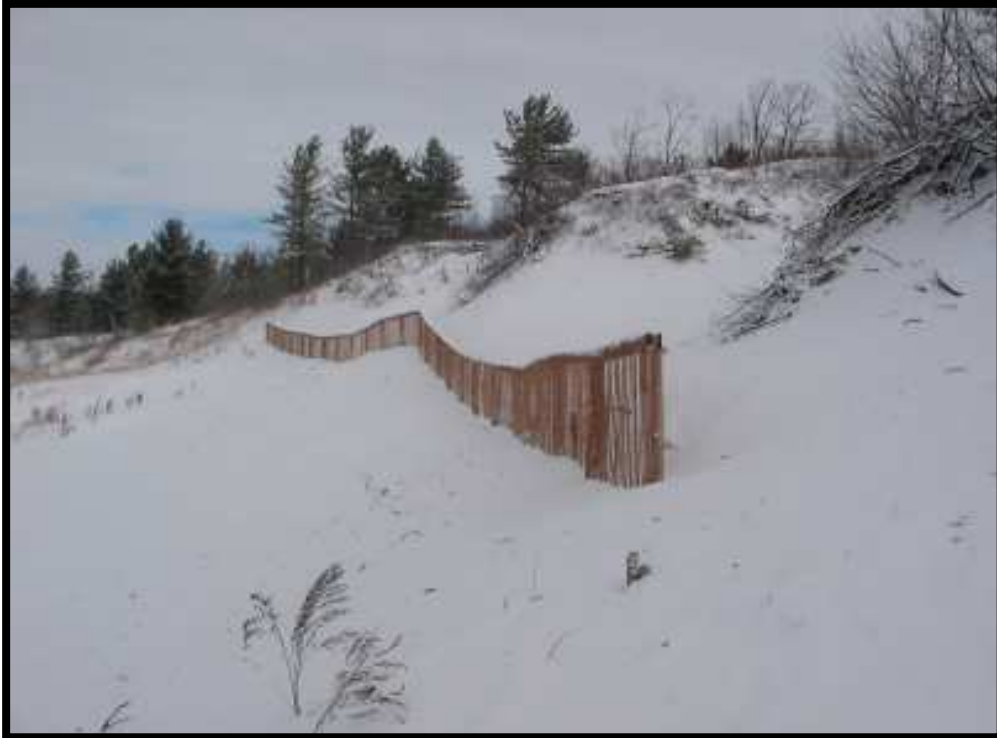
**Figure 11: Snow fences erected at Bluewater Beach in the fall 2006**

A phased implementation plan is proposed in this document. The Phase 1 report provided a biological description of the area together with recommendations for protection in 2006. Some fencing was implemented in the late summer and signage erected (Figures 11 and 12)

The effect of the preliminary fencing was assessed to determine whether it has stood up well to the weather and has started to accumulate sand around its base. The fencing generally appeared to be in good shape. One snow fence across the blow out section by Nicole Avenue had been tampered with, however the Bluewater Beach committee was aware of this damage

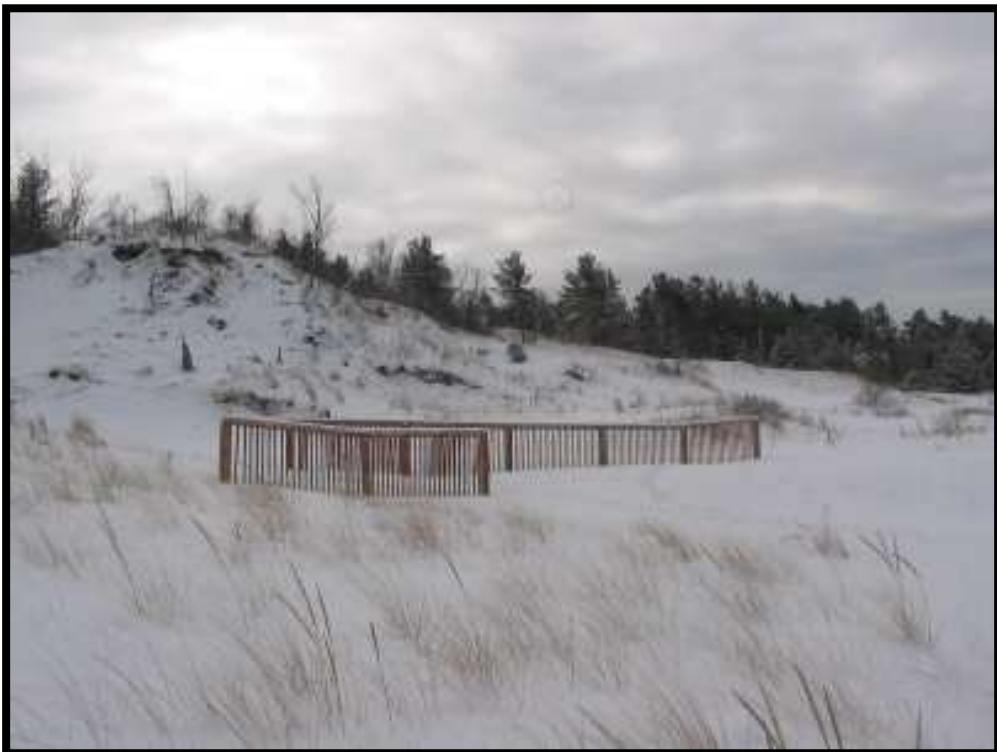
**Figure 12: Snow fences erected at Bluewater Beach in the fall 2006**

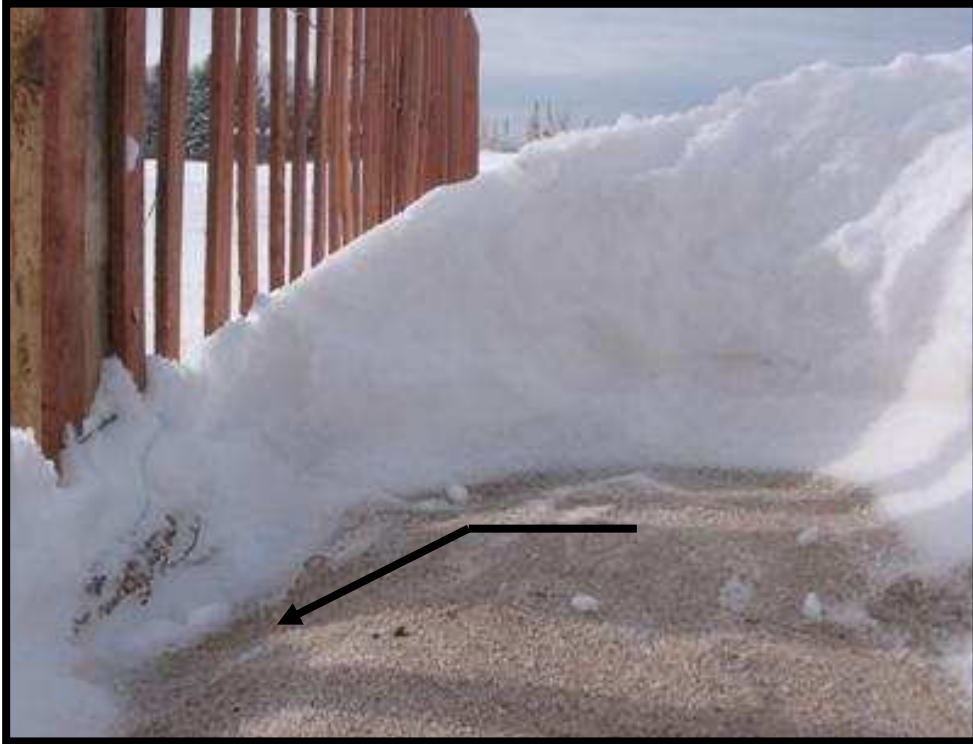
**Figure 13: Sand build-up as a result of snow fence**

The effectiveness of this fence will depend upon the availability of sand that can come from the beach area. This is a function of the sand source, particle size, wind direction and speed, and moisture content. It is expected that sand will start to accumulate around the fence during the fall (2006) and spring (2007) period, though the fencing will prevent trampling and allow vegetation to start recovering. There are already several patches of dune grasses that will probably start expanding during the summer.

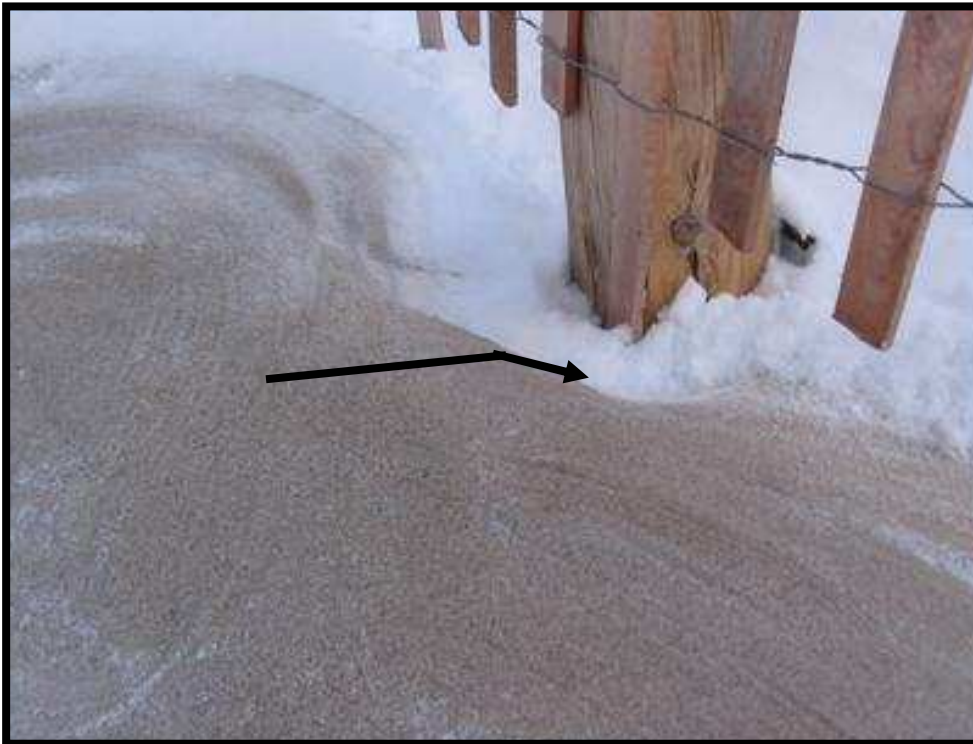
**Figure 14: Sand build-up as a result of snow fence**
